TECHNICAL SERVICE BULLETIN

3.5L EcoBoost/2.7L EcoBoost - Illuminated MIL With DTC P04F0 And/Or P144C

19-2132

30 April 2019

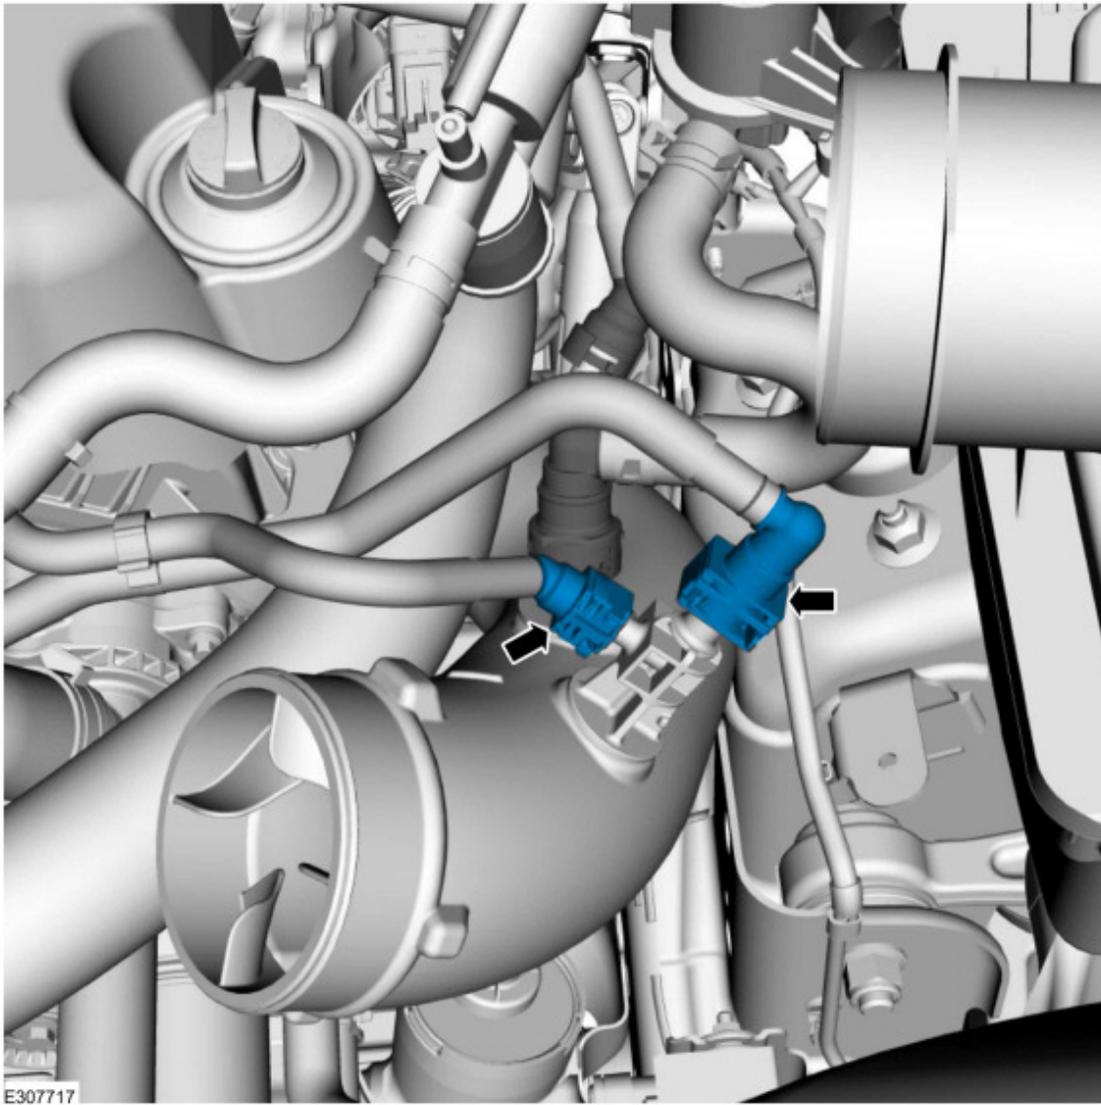
- Vapor line connections to the vacuum port side and pressure port side of the ejector. Refer to Figure 1 for 3.5L and Figure 2 for 2.7L.
- Vapor line connection at the port on air intake system (AIS) duct at throttle body inlet. Refer to Figure 3 for 3.5L and Figure 4 for 2.7L.
- Vapor line connection at the vacuum side of purge valve (side port on the purge valve). Refer to Figure 5 for 3.5L and Figure 6 for 2.7L.

1. Visually inspect and push and pull on each of the following EVAP connections to verify a proper connection:
